CONNECTICUT RIVER BASIN
GOSHEN, MASSACHUSETTS

HIGHLAND LAKES-LOWER LAKE DAM
MA 00598

PHASE I INSPECTION REPORT
NATIONAL DAM INSPECTION PROGRAM

AUGUST 1981

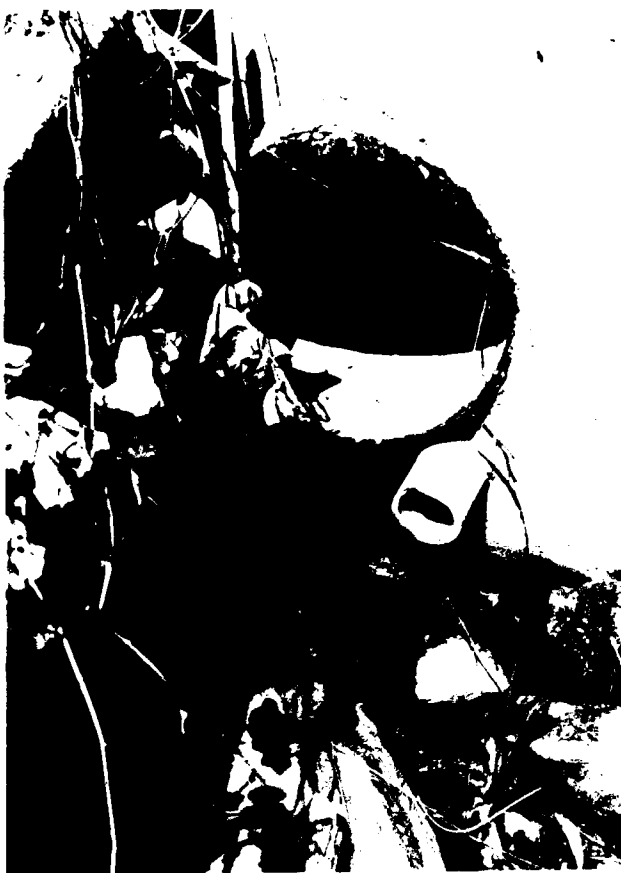
PHOTO NO. 5 - Outlet pipes and
headwall at down-
stream toe.
